HERITAGE ADVISOR'S REPORT/MEMO

Proposal: Demolition of Penoyre Cottage, Wesley Hill; 109 Duke Street Castlemaine
To: Fiona McMahon
Date: 29 June 2011

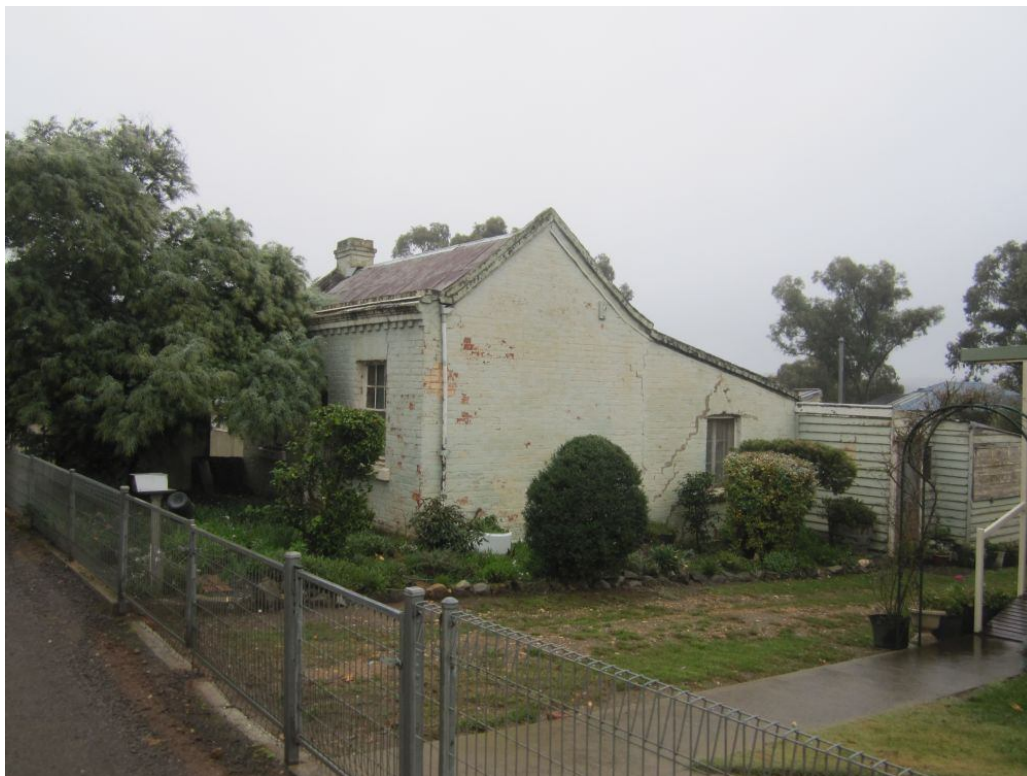
Figure 1 View from east

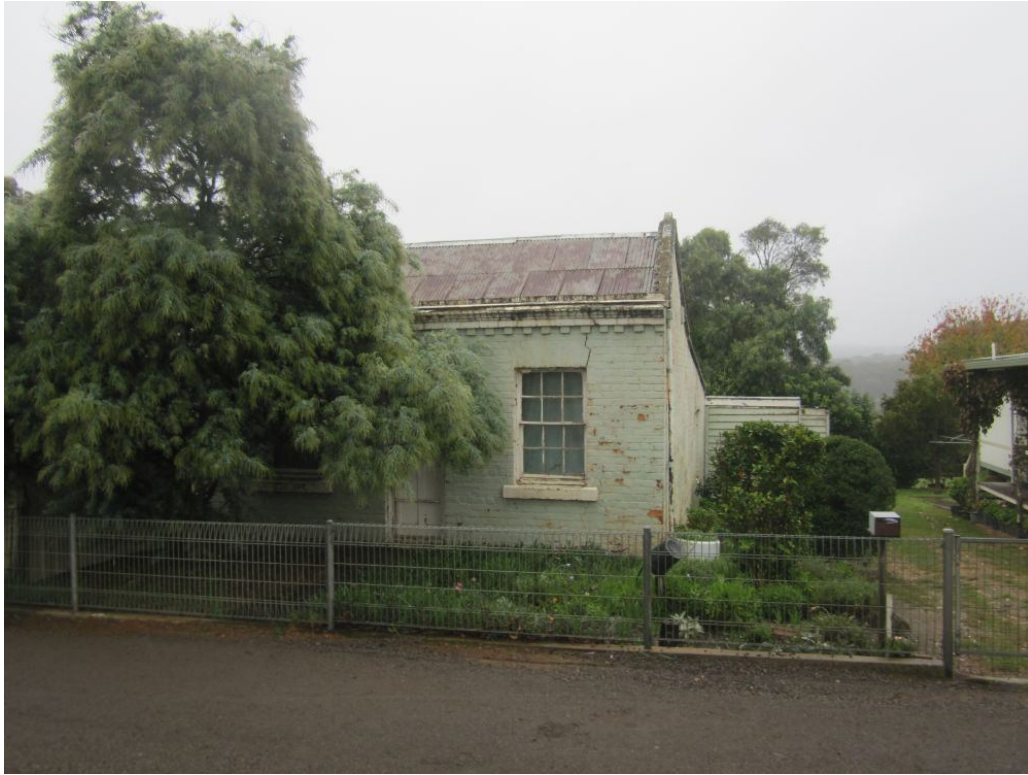
Figure 2 Front view

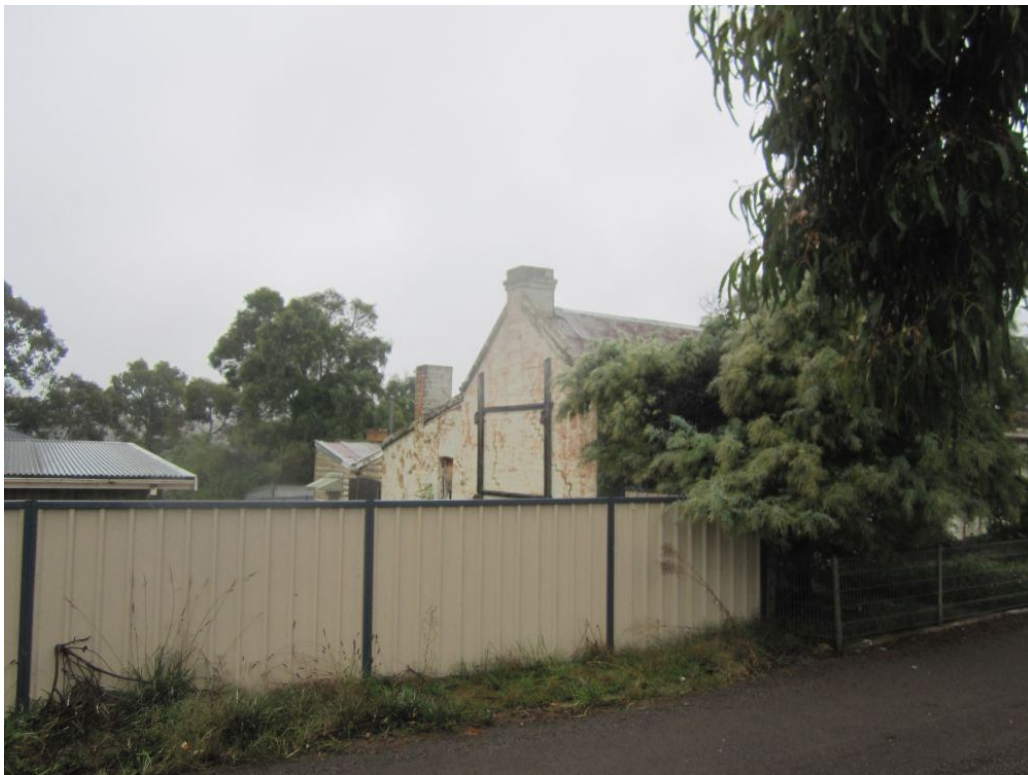
Figure 3 View from west - Castlemaine side

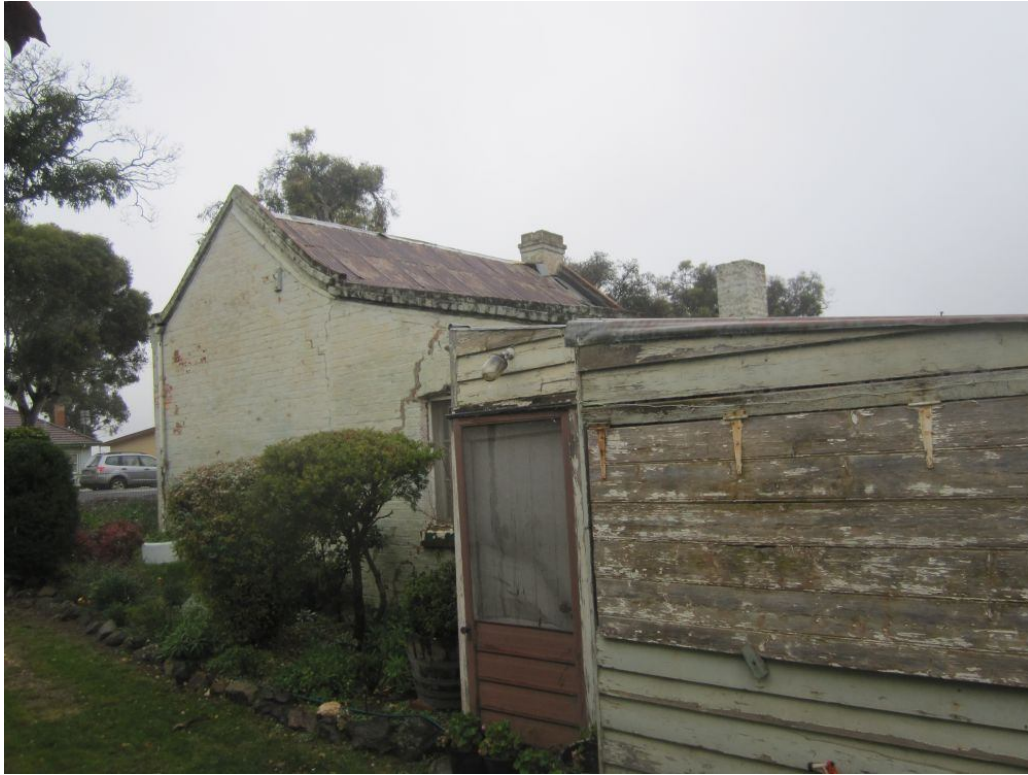
Figure 4 Rear view east side

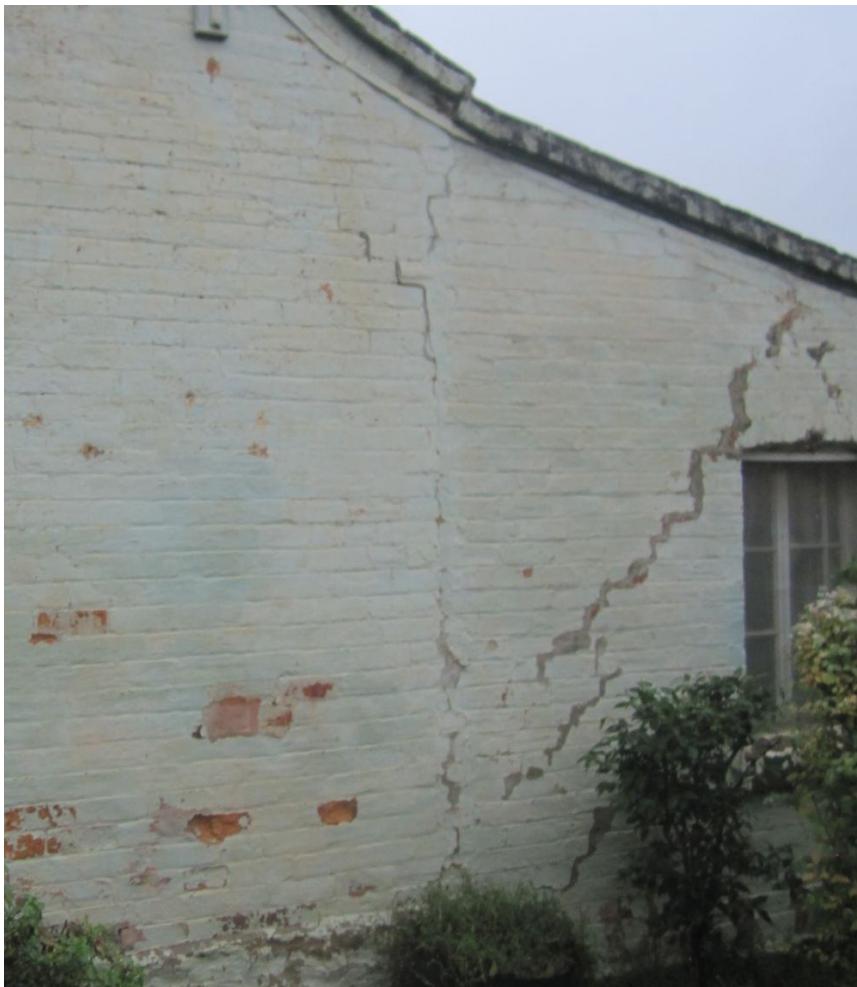
Figure 7 Connection between gable and skillion sections – note casement window

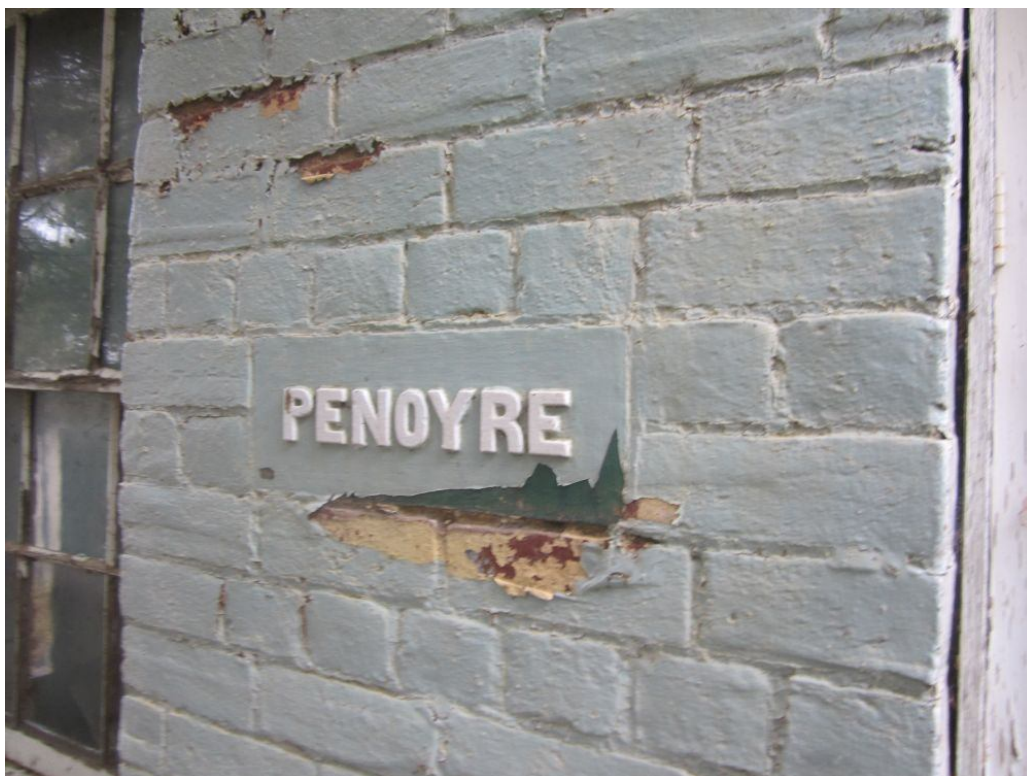
Figure 5 Name plate left of door note exposed brickwork below paint

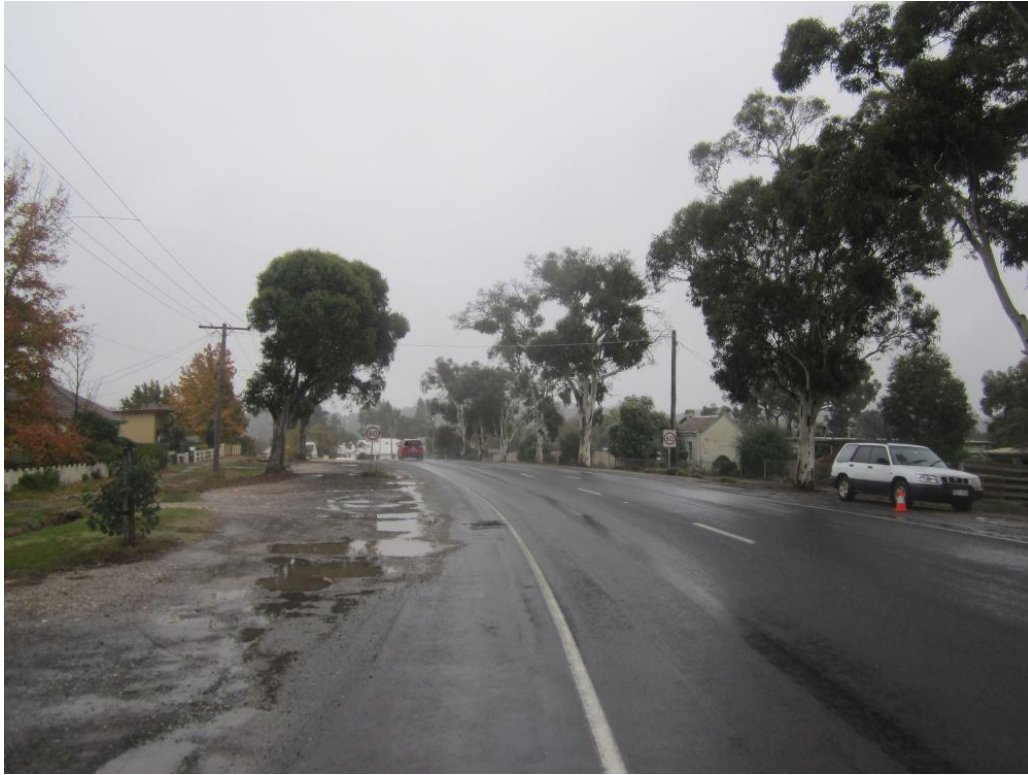
Figure 8 View from east when heading to Castlemaine from Chewton – note conspicuous location on bend of road

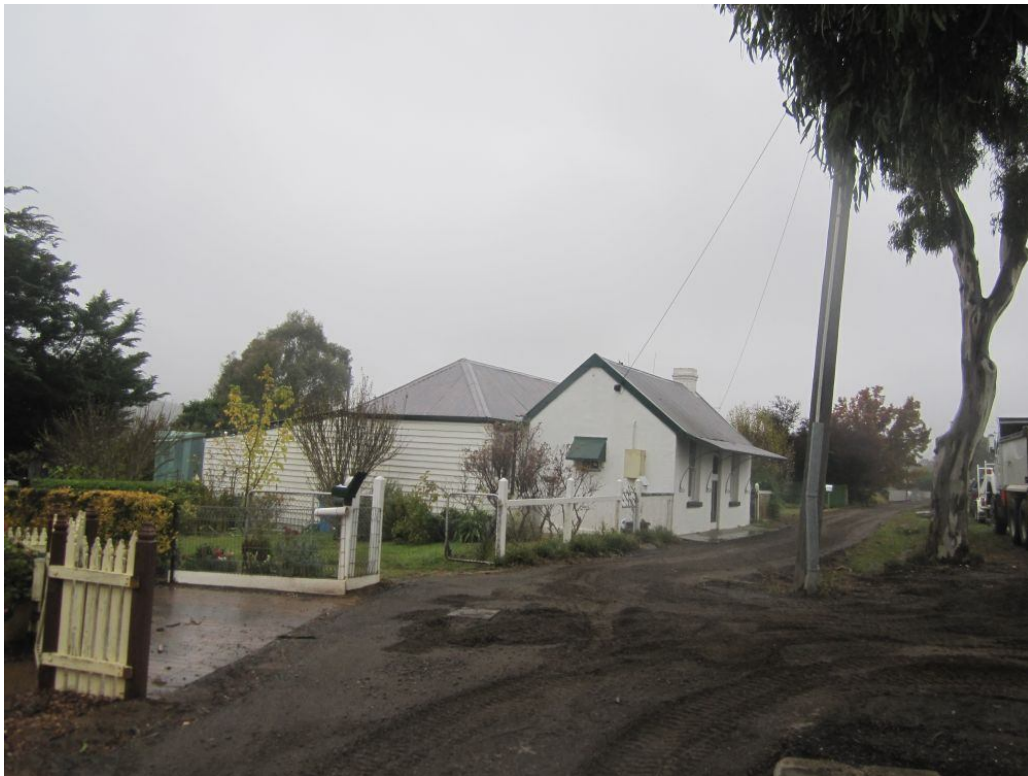
Figure 9 Nearby house to the east, also not covered by an HO.

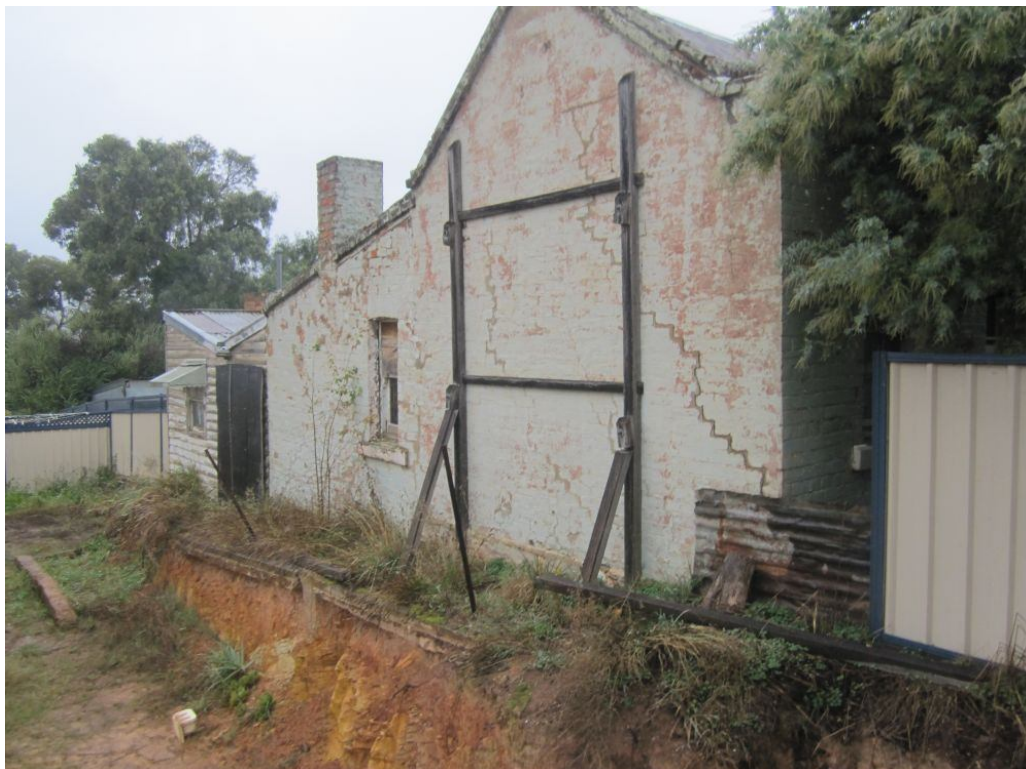
The building does not demonstrate rotation on the side wall to a degree that cannot be readily rectified. The current props are too flimsy to serve any structural purpose. The excavation does not appear to be the main factor contributing to the cracking along the front façade, however, or the separation of the internal wall from the side wall shown in the surveyor's report. The distance of the building from the excavation is outside the natural angle of repose, given stability of the foundation material. However, the excavation does contribute to drying of the foundation material, especially as it is exposed to the hot west sun.

Figure 10 Excavation on adjacent property made many years ago. This wall has not demonstrated any marked rotation.

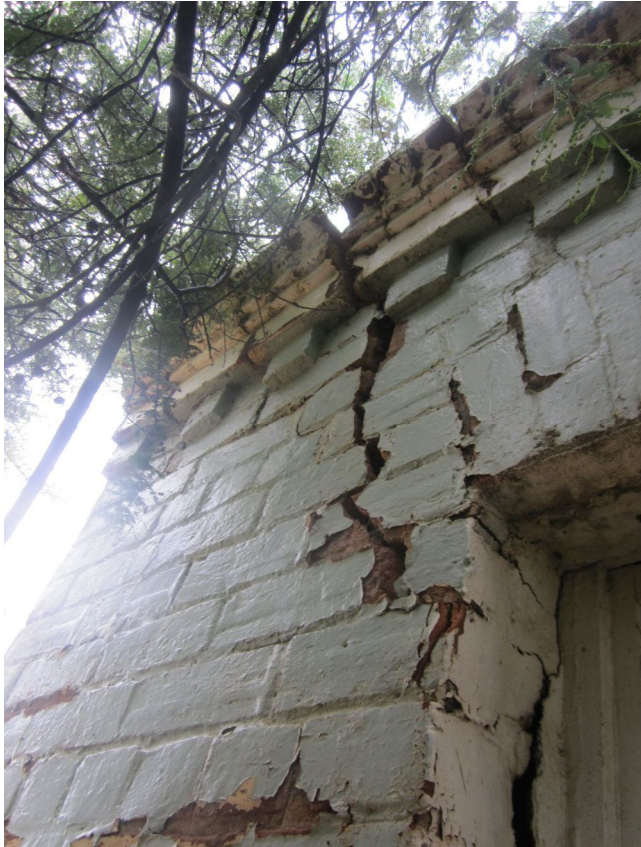
It is my view that large wattle tree appears to be the main cause of cracking of the brickwork, through excessive drying and shrinkage of the foundation material in drought periods near the tree. This is particularly bad tree species to plant near a building as it is able to extract maximum moisture from the ground. This shrinkage movement is transferred to the weakest part of the wall, that section above the nearest window to the tree, although the roots may extend for some distance seeking moisture. Such shrinkage also causes internal walls to separate from external walls due to differential in shrinkage. Removal of the tree and stabilising the surrounding 1 metre of the building with a surface seal would stabilise the moisture content. Some supplementary underground moisture injection may be required along the west. Then tie rods in appropriate locations and minor brick repairs using lime mortar would be sufficient to restore the brickwork.

Figure 11 This is the worst external cracking, above the window nearest the tree and corner of the building, the weakest part of the structure. Some minor rebuilding is now required to rectify the alignment, and to replace damaged bricks. Note elaborate parapet detailing.
